AERIAL PHOTOGRAPHIC ANALYSIS OF NINE
PRIORITY CERCLA HAZARDOUS WASTE SITES

Minneapolis-St. Paul, Minnesota

M. M. O'Toole
Environmental Programs
Lockheed Engineering and Management Services Company, Inc.
Las Vegas, Nevada 89114

GENERAL MILLS/HENKEL CORP.
MINNEAPOLIS, MINNESOTA

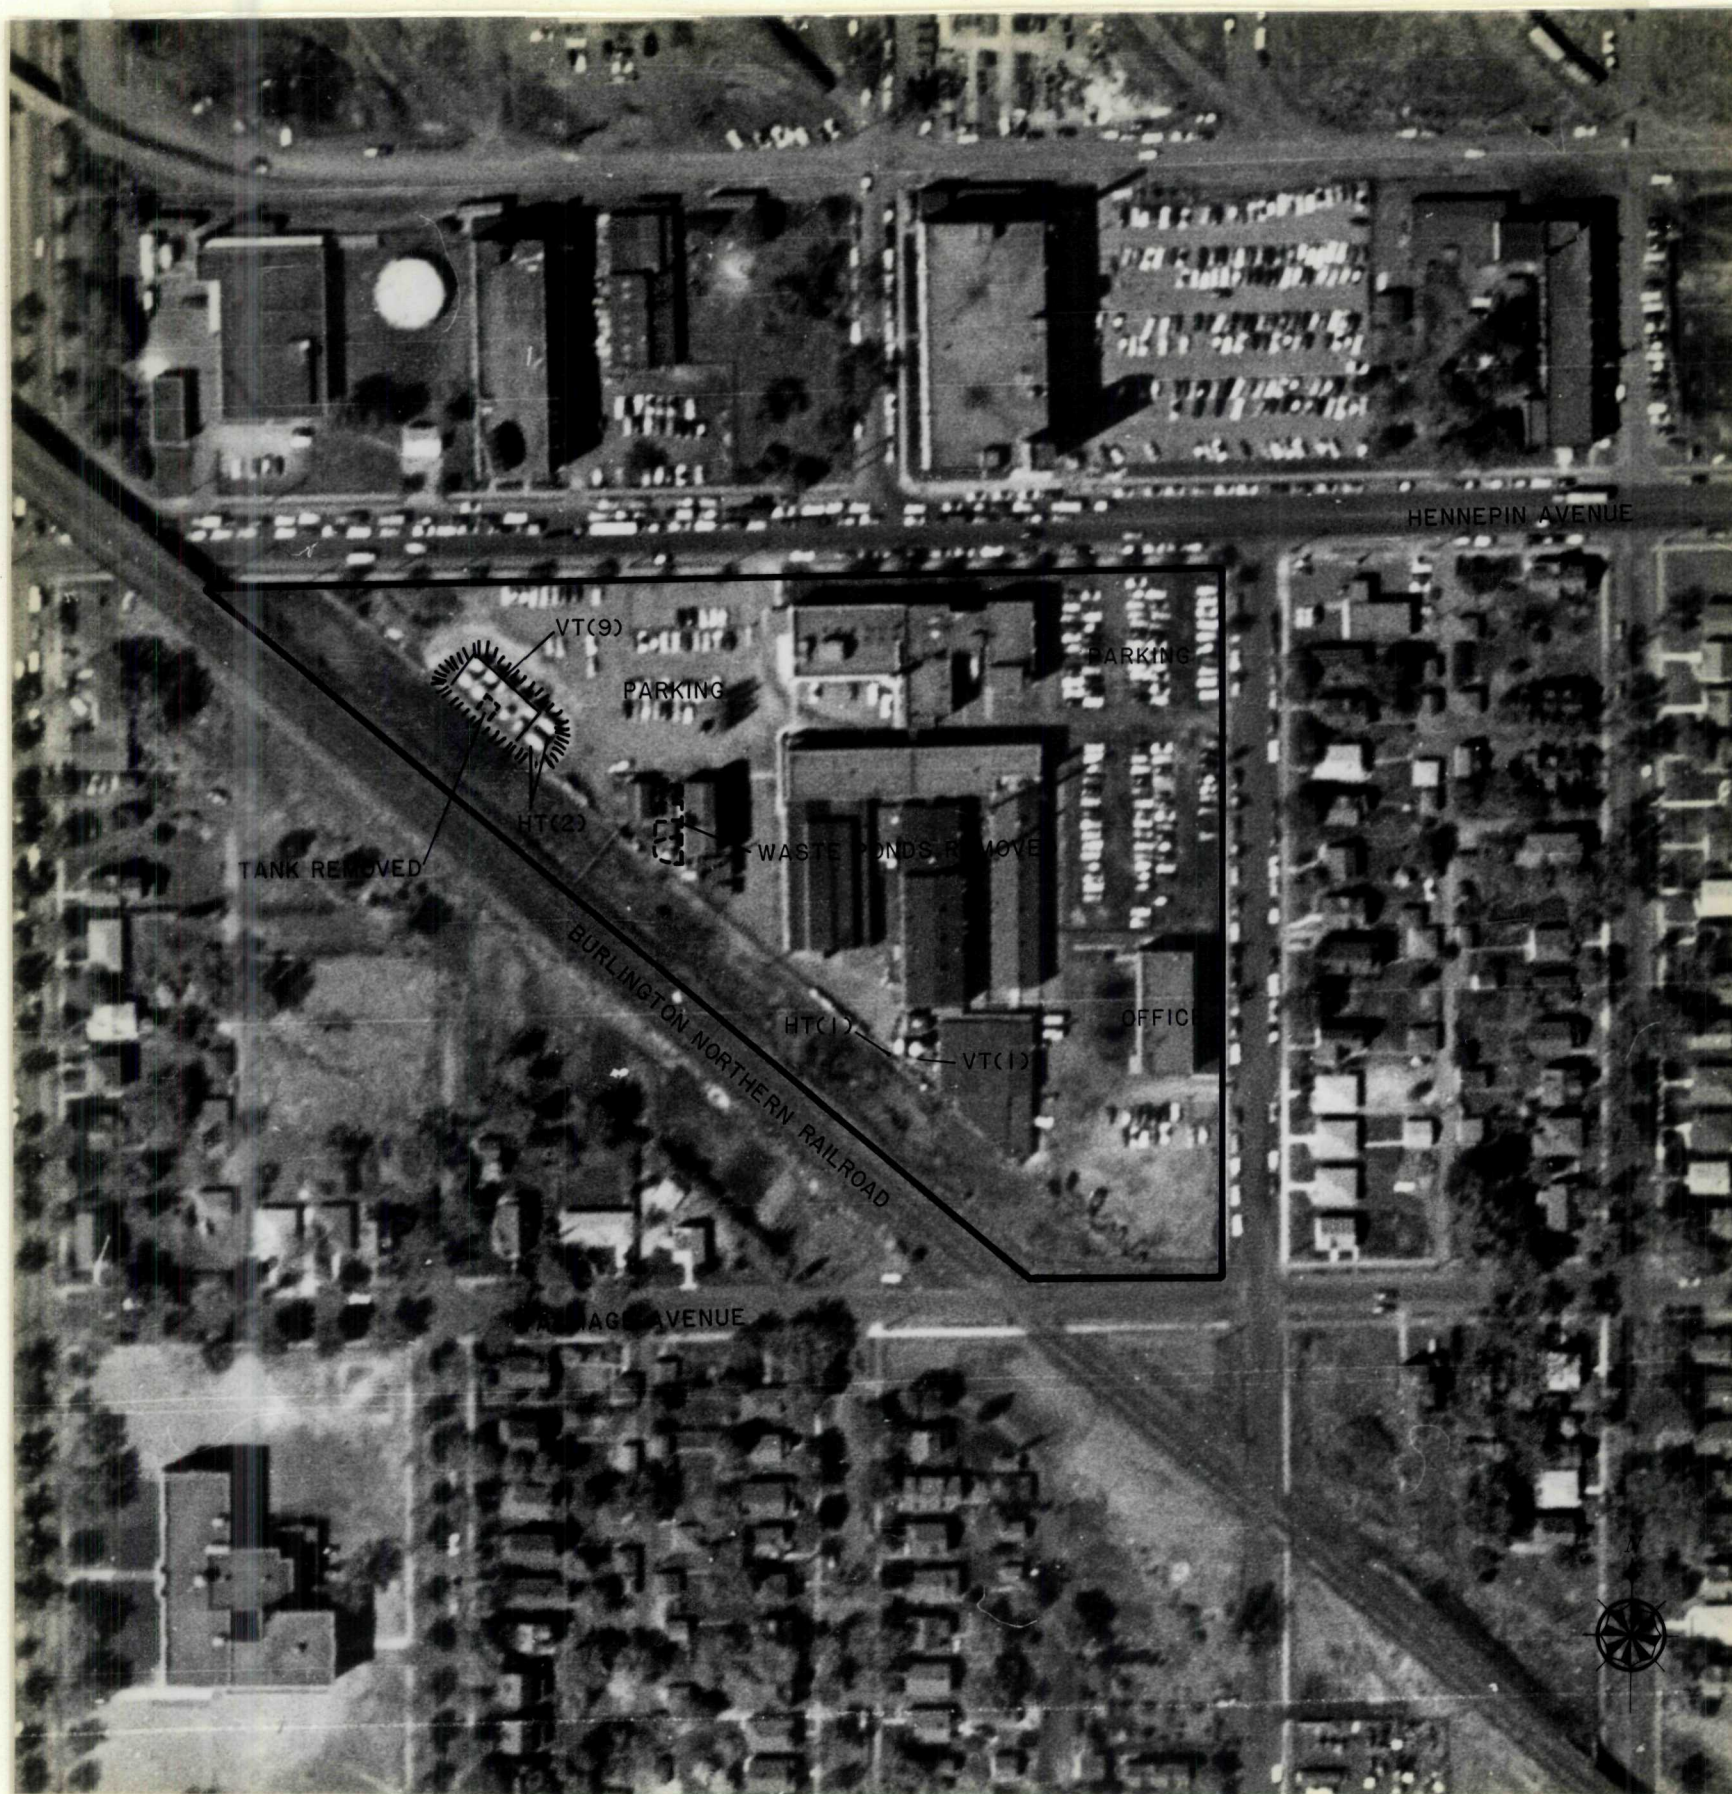
Figure 10. General Mills/Henkel Corp., May 6, 1957. Approximate scale 1:2,000.

Figure 10 shows a few changes at the site since 1953 (Figure 9). One of the vertical tanks in the tank containment area has been removed. The four waste ponds previously located southeast of the tank containment are no longer evident.

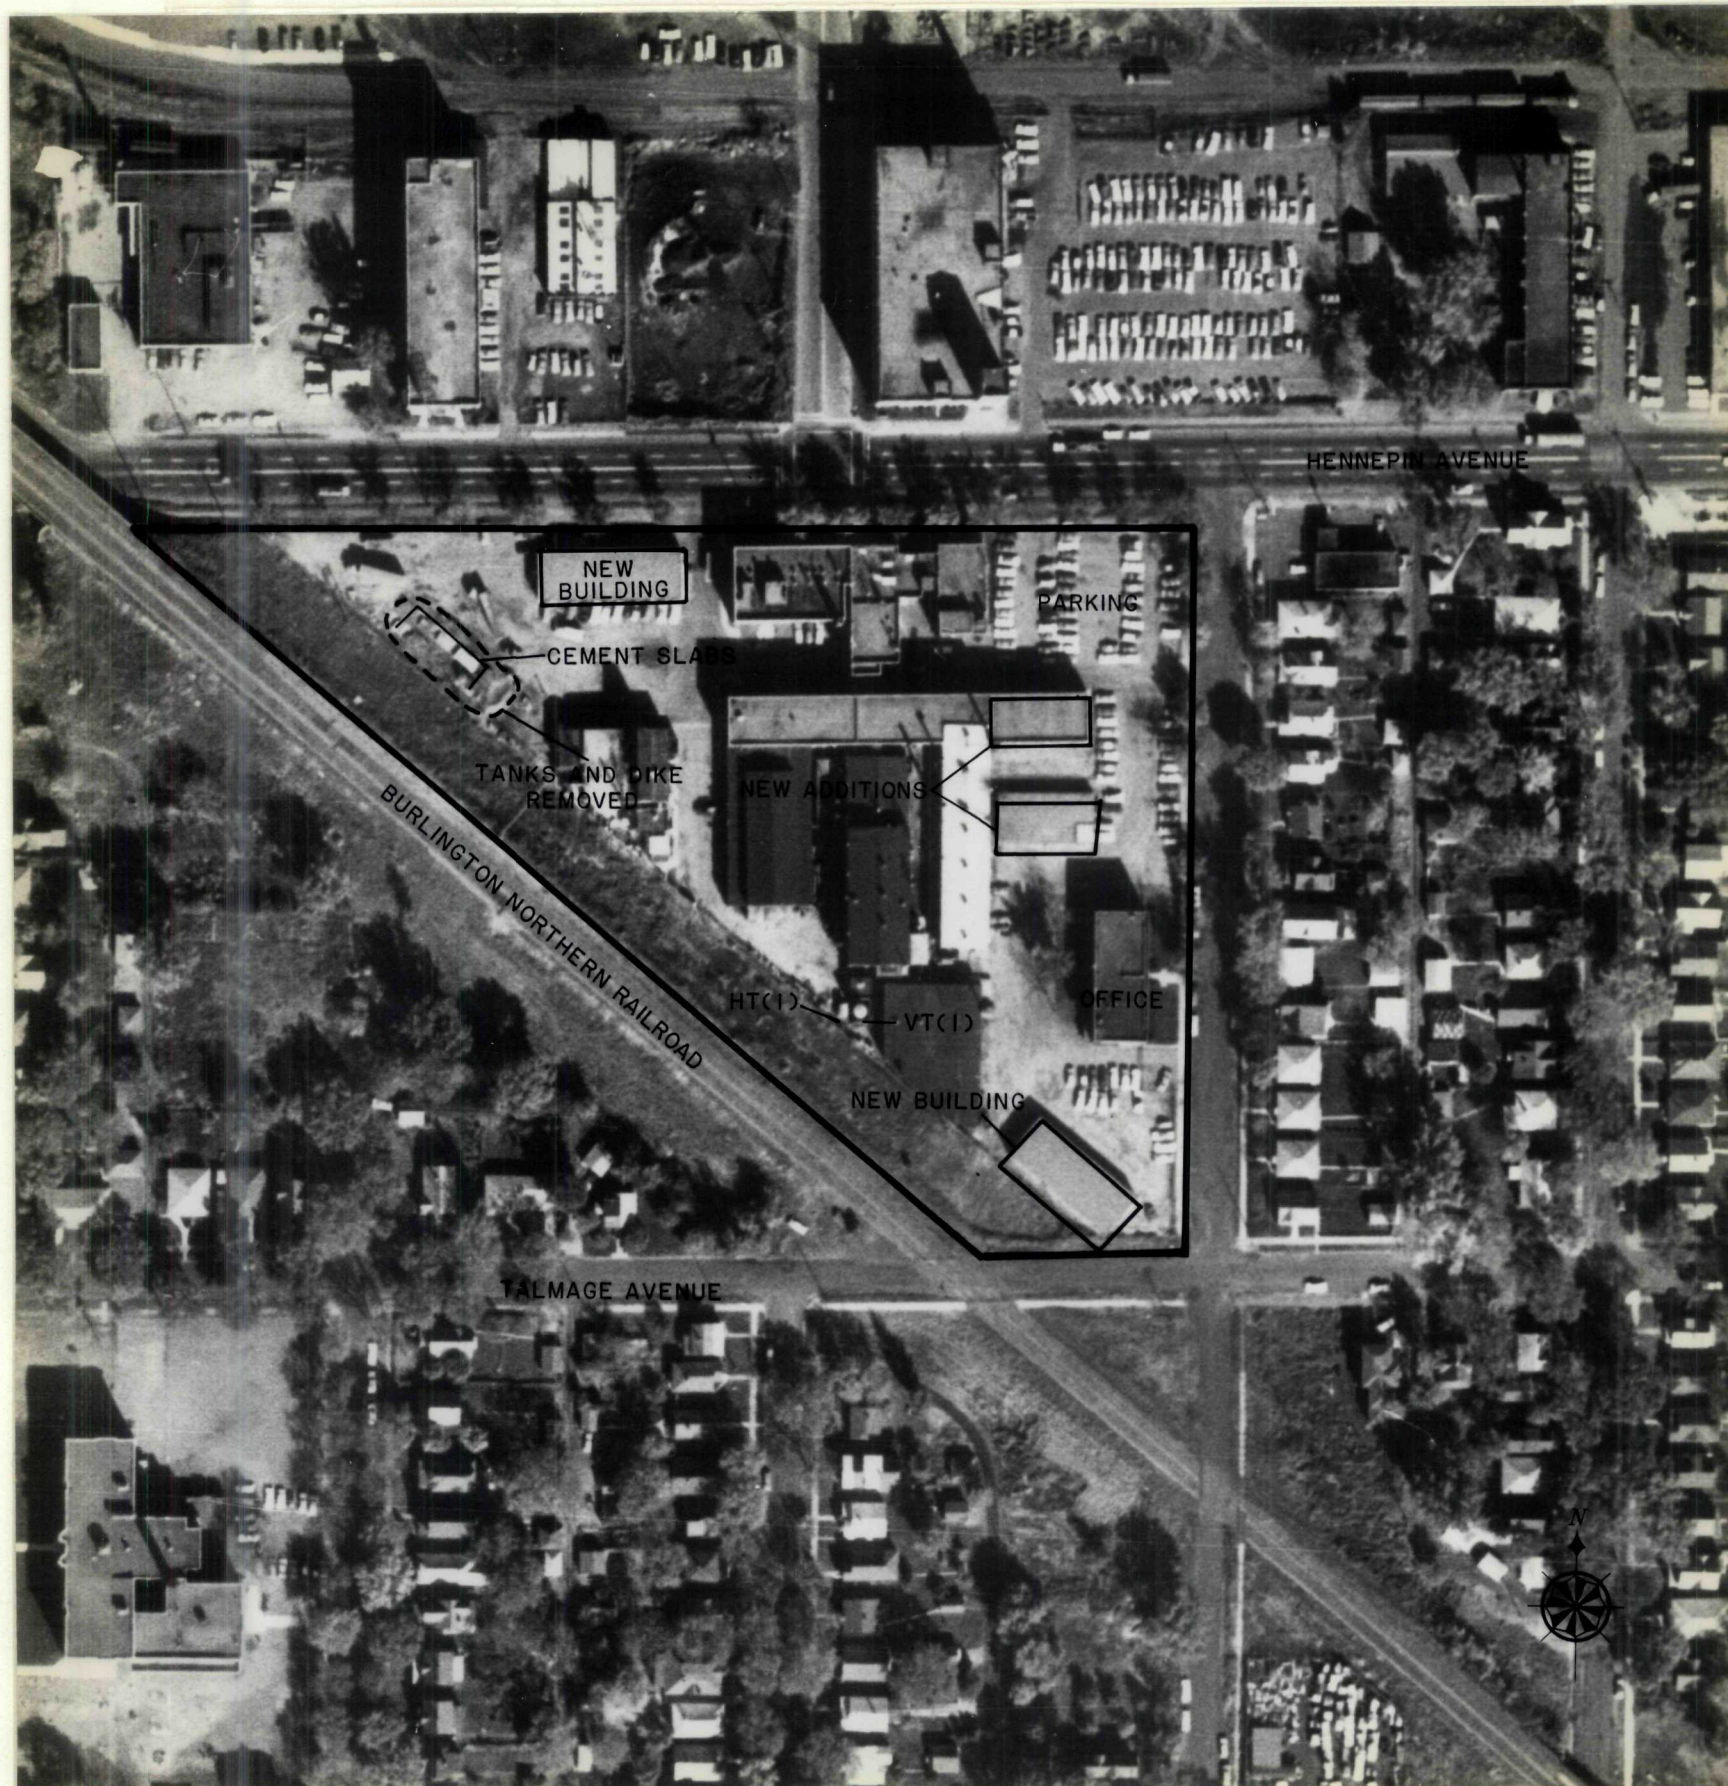
Figure 11. General Mills/Henkel Corp., October 14, 1964. Approximate scale 1:2,000.

Figure 11 shows the site after the facility was sold to Henkel Corp. The site now contains two new buildings and two new additions to the main building complex. The liquid storage tanks and the confinement dike have been removed from the northwest corner of the site. The area has been leveled and four cement slabs now cover that area.

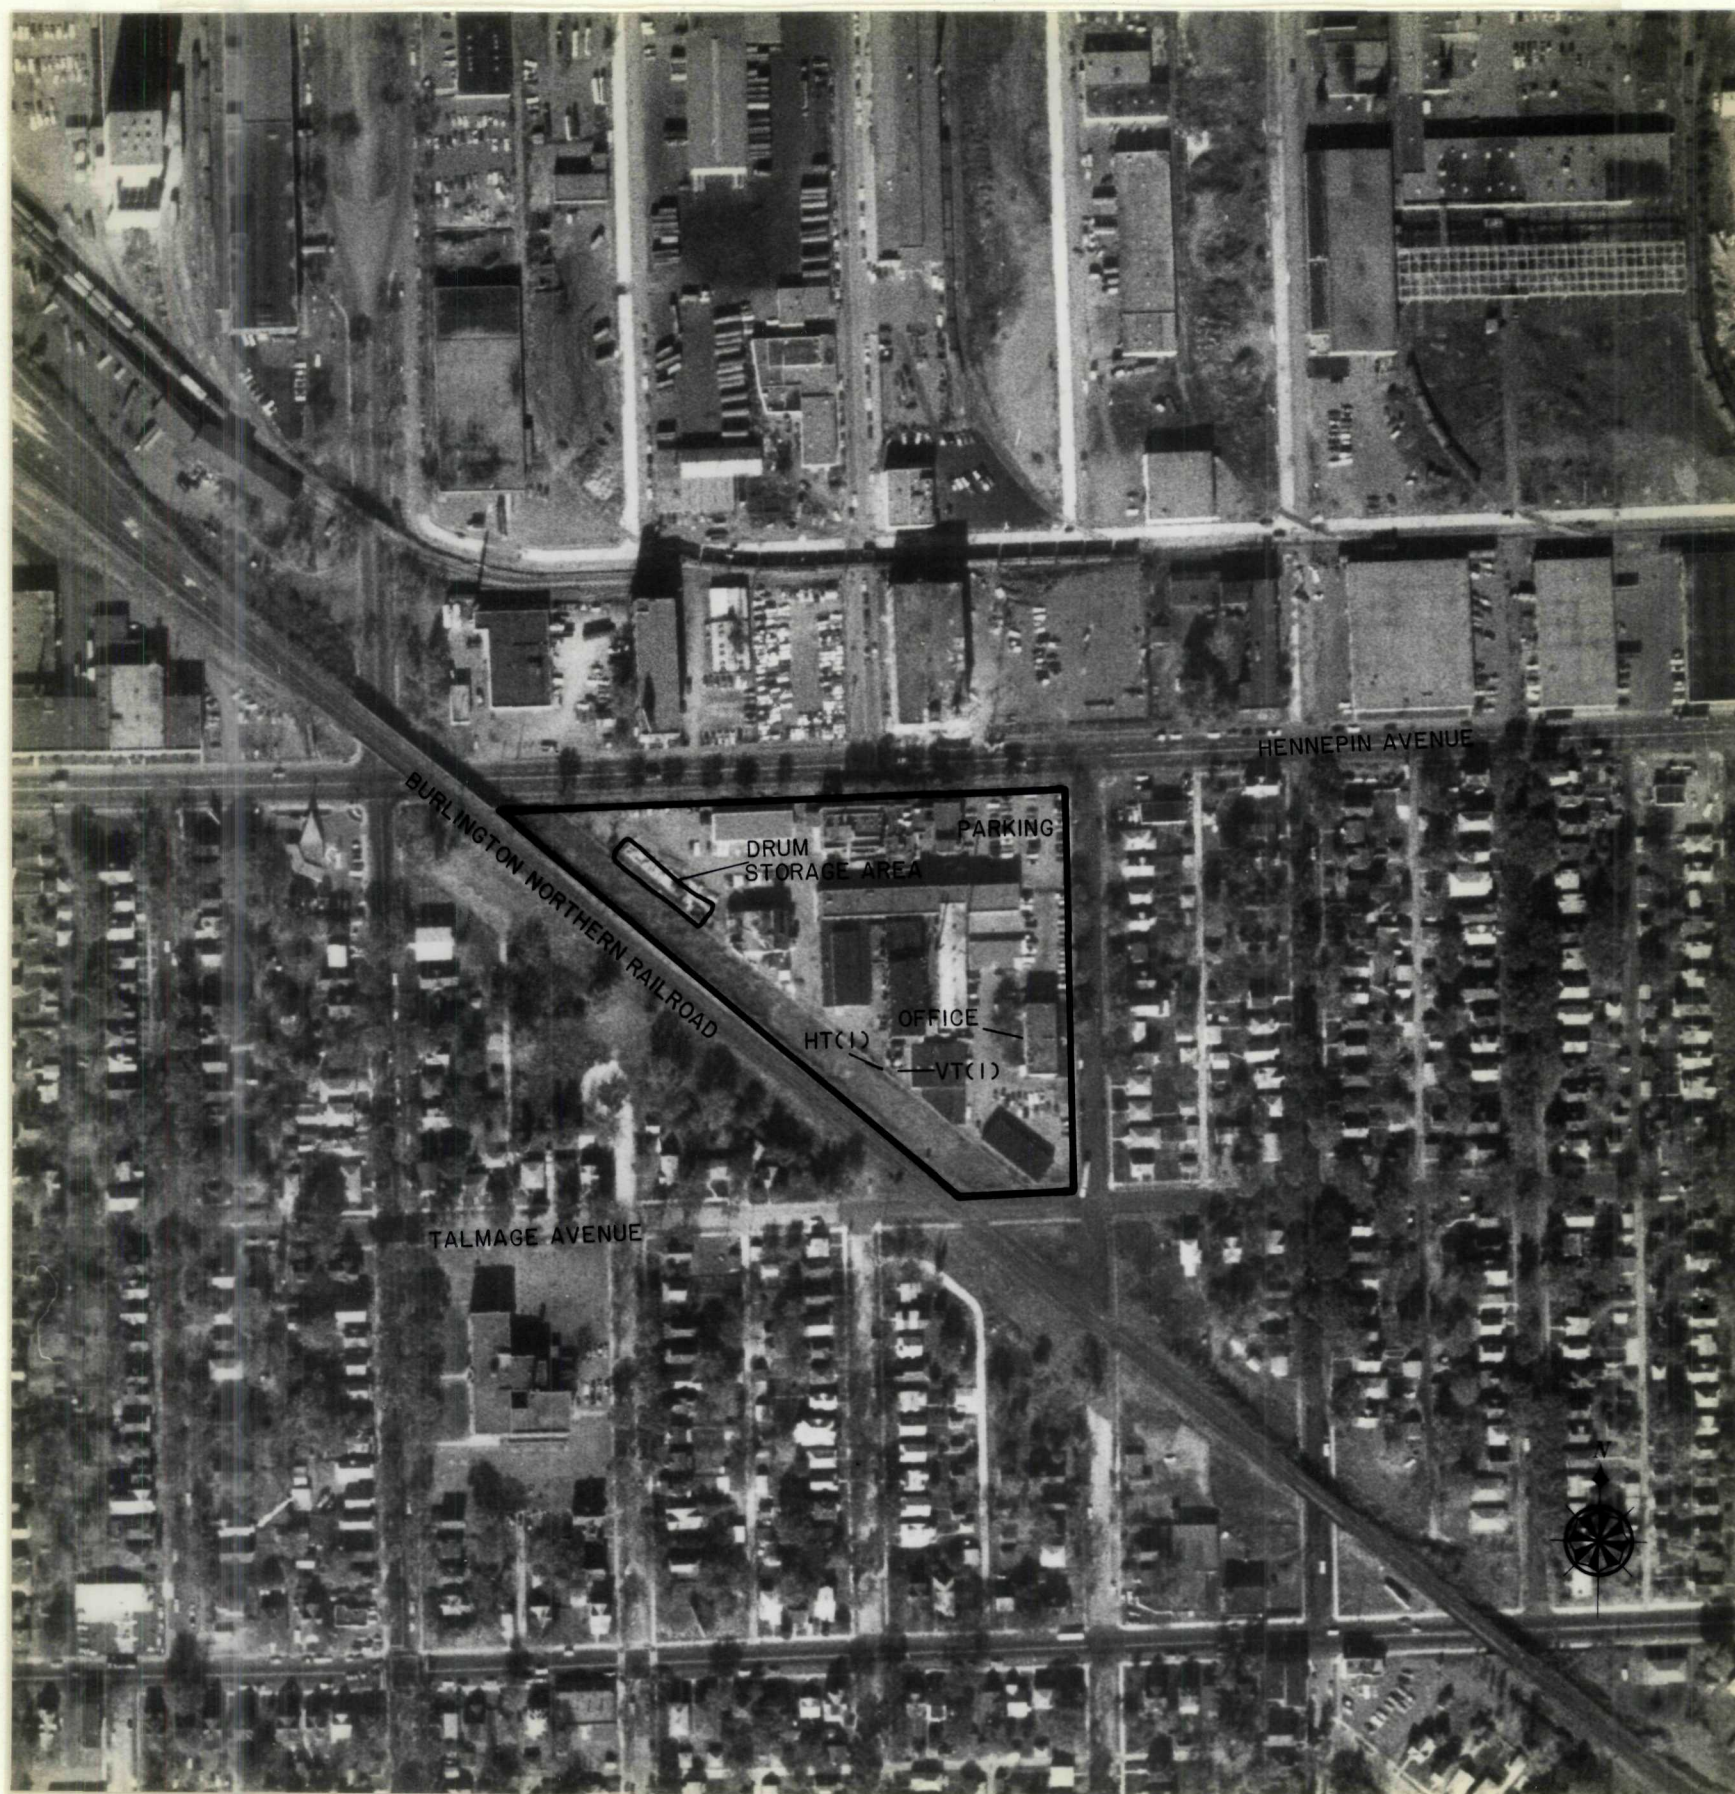
Figure 12. General Mills/Henkel Corp., October 28, 1969. Approximate scale 1:3,500.

Figure 12 shows only one significant change at the site since the last overflight (Figure 11). The area where cement slabs were seen in 1964 has been expanded and is a drum staging platform. The scale of the original photograph (1:35,000) precludes estimating the number of drums being stored there.
